Subject: 3809 Noncompliance Issues at Miller Rock Mine Site

Mine Inspection Report

Subject: Trip Report to the Miller Rock Mine

Location: T 22S, R 6E, Sec 26 approximately NW quarter, SE of Emery Utah.

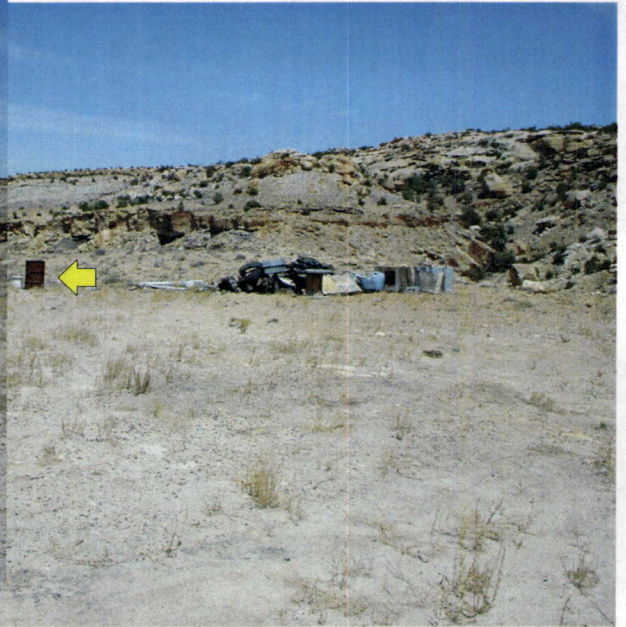
2. During periods of non-operation, the site must be maintained in a safe and clean condition (43 CFR 3809.3-7). As shown in the attached photographs there is trash all over the mine site. This is also considered a violation of 43 CFR 3809.2-2 since all operations must be conducted to prevent unnecessary or undue degradation.

North working area with camper and trash. Possible incinerator (yellow arrow).

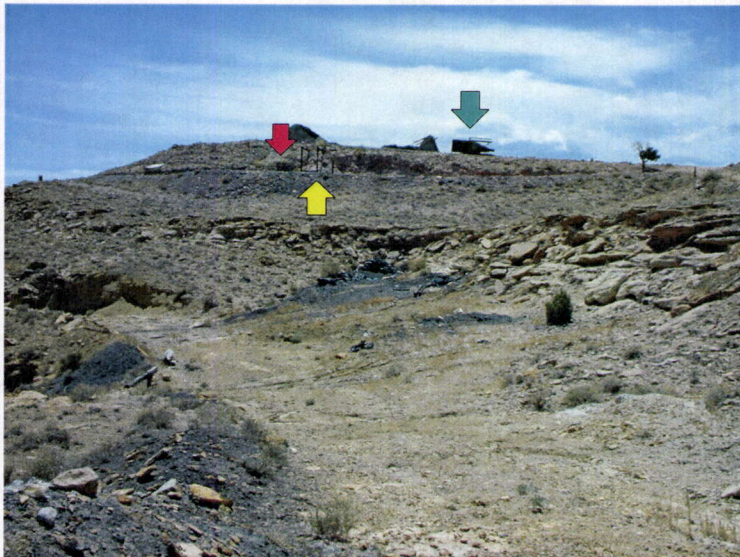
4. Several 55 gallon drums and 5 gallon containers are on site and not labeled. Drums and containers must be labeled in accordance with Federal laws and stored in accordance with there associated MSDS sheets. This is a violation of 43 CFR 3809.2-2 which states that "All operations... shall be conducted to prevent unnecessary or undue degradation of the Federal lands and shall comply with all pertinent Federal and State laws, including but not limited to the following..."In addition, this is a violation of 43 CFR 3809.1-3(d)(2) which states "All ... deleterious materials or substances, and other waste produced by the operations shall be disposed of so as to prevent unnecessary or undue degradation and in accordance with applicable Federal and State Laws."

North East looking South. Note what appears to be the remains of a bin that is inoperable on the top of the picture (turquoise arrow) and there is a crusher structure below the ore pile (yellow arrow). 55 gallon drums (red arrow) The dark area in the middle of the picture is shown in a close-up in the picture to the right.

8. There are several items at the site that are not appropriate equipment to use in the extraction process and some of this equipment is inoperable. Therefore, in accordance with 43 CFR 3715.2(e) this equipment should be removed.

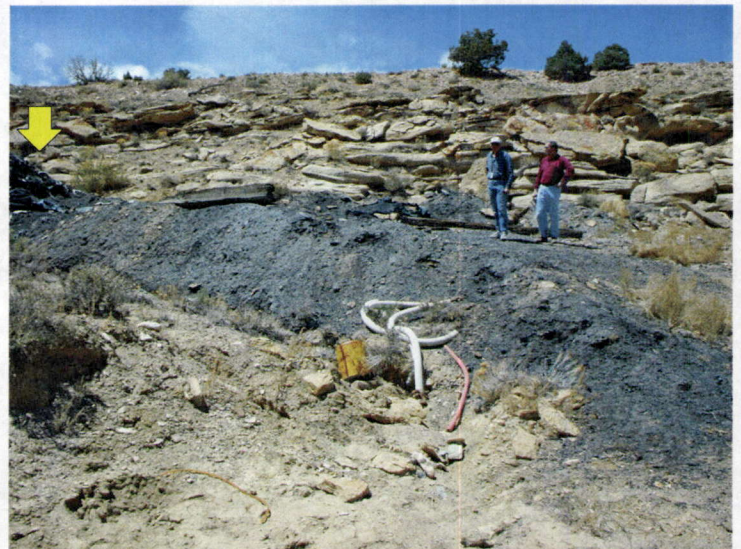
There is a lot of trash and plastic mixed with the material on the left side of the picture (yellow arrow).

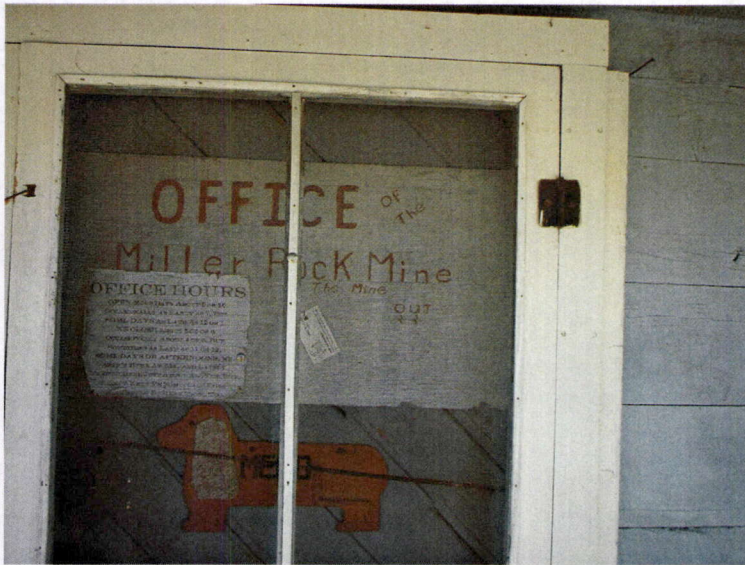
Close-up of the Mine Office

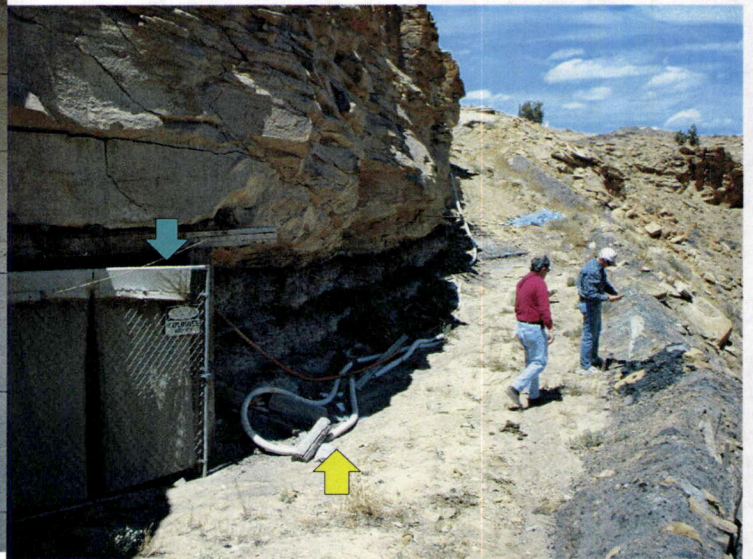
1. There appeared to be an unsecured area where explosives may be stored or present with a shot wire that leads into to the portal with the explosive sign on it. This is a violation of 3809.3-5 and 30 CFR 57.6123. The operator should be contacted as soon as possible to determine the contents of this area. In addition, the area should be inspected to ensure there are no explosives present. Explosives may not be left on site during periods of non-operation. Also, an inspection since May 9, 2002, by Dean Nyffeler, noted an open box of primer cord in the building. This is a violation as noted above.

East Side Portal (Explosives Magazine). Trash all over the place. Note possible shot wire going over the opening (turquoise arrow). Air lines (yellow arrow)

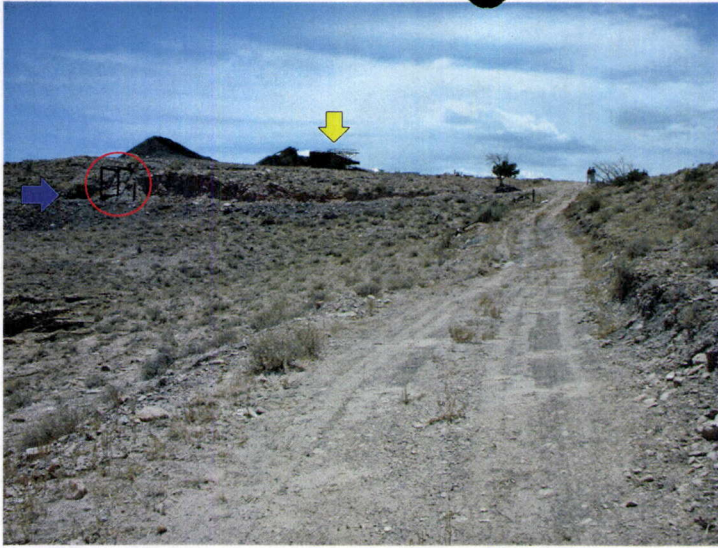
Road coming down from the ore pile with the inoperable bin (yellow arrow) in the background. This is the same road that is on the left side of the next picture. A closer view of the in operable crusher structure (red circle). 55 gallon drums in the shadow (purple arrow).

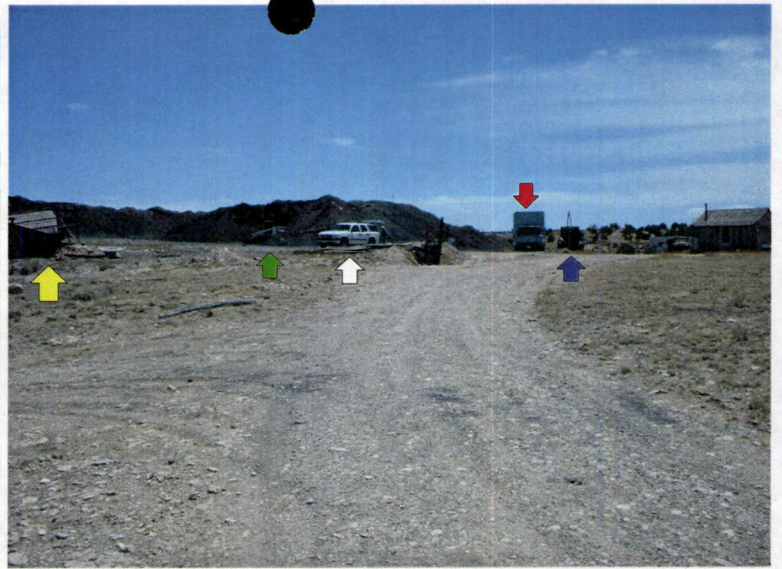
7. There was a no trespassing sign on the ore pile. Was the information provided in accordance with 43 CFR 3715.3-2 to allow concurrence with the posting of this sign? Also, at one point in time there appears to have been a chain across the access road. Was this also concurred with under the 3715 regulations?

The single ore pile for the operation in the background. On the left side is the bin (yellow arrow). The white vehicle (white arrow) in front of the ore pile is the BLM vehicle. Just left of the BLM vehicle is a bobcat loader (green arrow). The "Sears" truck (red arrow) is left of the truck with the boom (purple arrow). There are some other buildings to the right of the boom truck that do not show up in the picture. The "Mine Office" is on the right hand side of the picture.

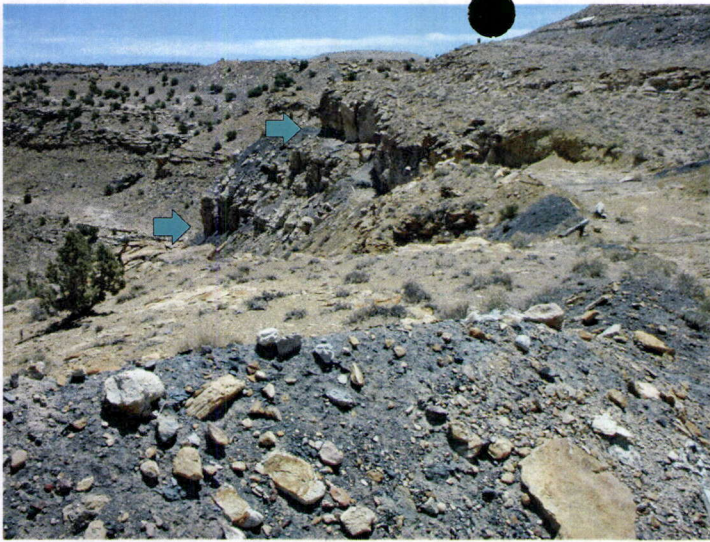
3. The workings are unsafe because the operator has undermined the cliff face. One of the portals has been covered by the cliff face slumping down since the workings were inadequately supported. The other portals are open and not secured. The unsuspecting public can wander into the openings not knowing these workings are unstable. This is a violation of 43 CFR 3809.3-5 which states "Hazardous sites or conditions resulting from operations shall be marked by signs, fenced, or otherwise identified to alert the public in accordance with applicable Federal and State laws and regulations."

Picture of two of the cliffs undermined forming highwalls from a distance. Close up picture is on the right.

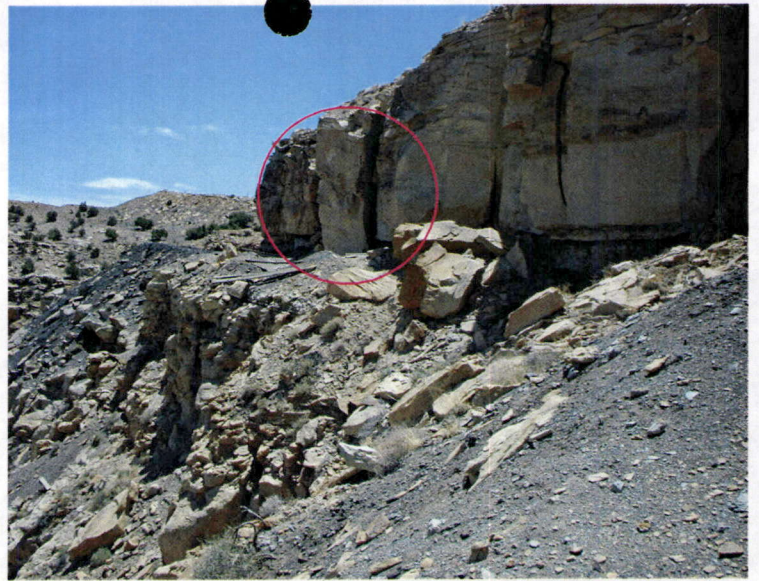
Upper cliff face which forms a highwall close-up. Note the block that has come down over an underground opening (red circle) and the material that is spalling off.

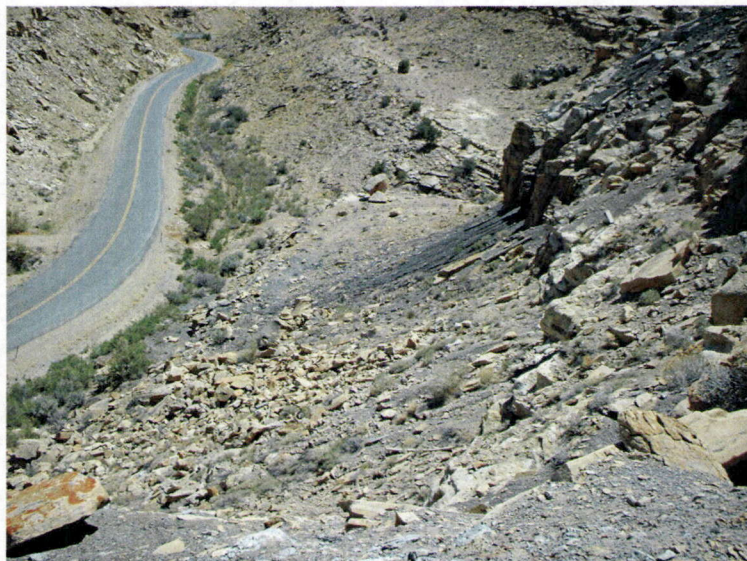
This is what lies below the this unstable cliff. This is the road from Emery to I-70 through Miller Canyon.
